ESTATES AND FACILITIES

10249 PLAYGROUND INSPECTIONS (Report B)

Annual Inspection Report

New Barn Park Play Area

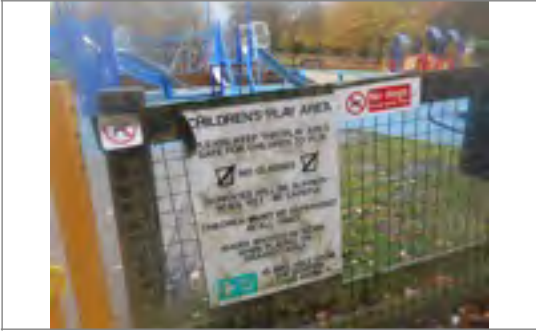
<p>Cable ties present.</p> <p>Recommendation: Consider removing these items.</p>	7
---	---	----------

<p>Signage in a below average condition.</p> <p>Recommendation: Consider new sign.</p>	4
---	---	----------

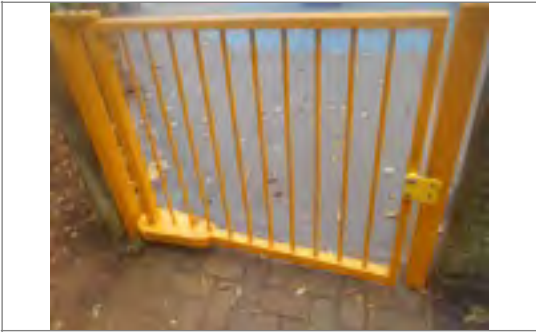
<p>Gate not fully closing.</p> <p>Recommendation: Adjust closing mechanism.</p>	7
---	--	----------

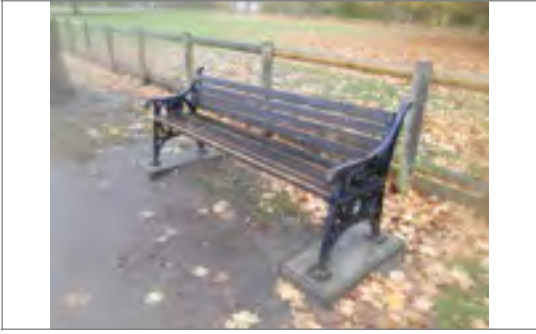
Slight decay evident.
Recommendation:
 Monitor this condition.

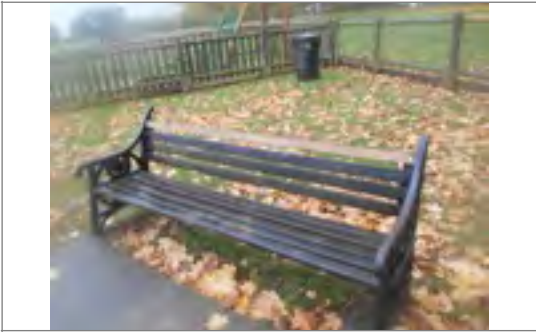
Thread projection evident.
Recommendation:
 Cut flush or dome nut as required.

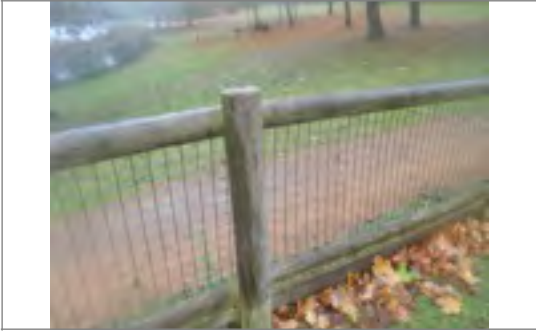
Decay/rot evident in most places. Recommendation: Consider replacing fencing.	8

As above finding. Recommendation: As above comment.	8

Fence posts broken in ground due to decay. Recommendation: As above comment.	8

As above. Recommendation: As above.	8

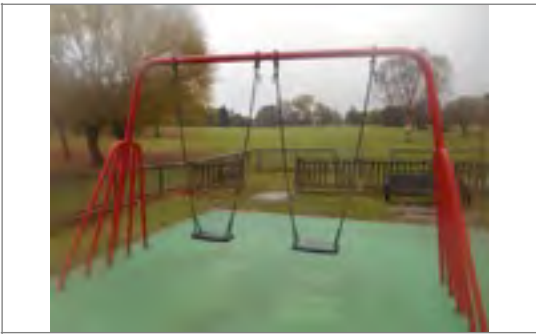
Rust/corrosion evident. Recommendation: Repaint as required.	5
	Recommendation:	
	Recommendation:	
	Recommendation:

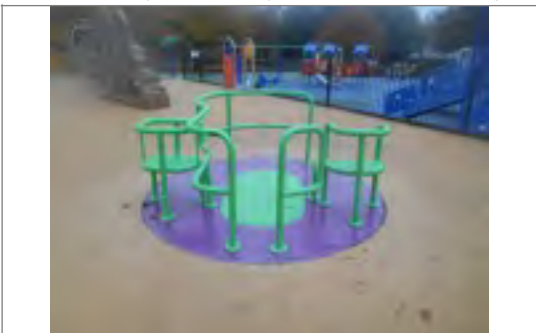
Slightly worn bearing and missing bolt. Recommendation: Monitor bearing and replace bolt.	5
	Recommendation:	
	Recommendation:	
	Recommendation:

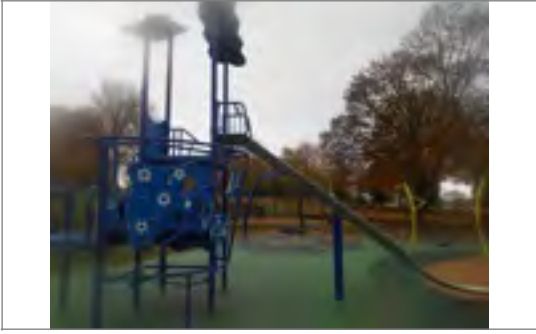
Slightly worn chains
Recommendation:
 Monitor and replace at 40% dia. wear.

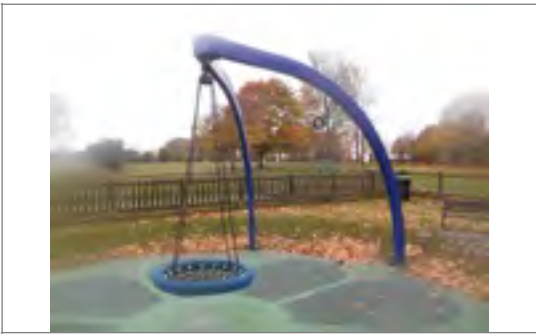
Damage to rope net. Recommendation: Monitor to repair/replace as required.	8
---	---	---

Slight chain wear evident. Recommendation: Monitor to replace at 40% dia. wear.	8
--	--	---

General maintenance. Recommendation: Follow manufacturers recommendations of schedule of maintenance and inspections of this unit.	8
---	---	---

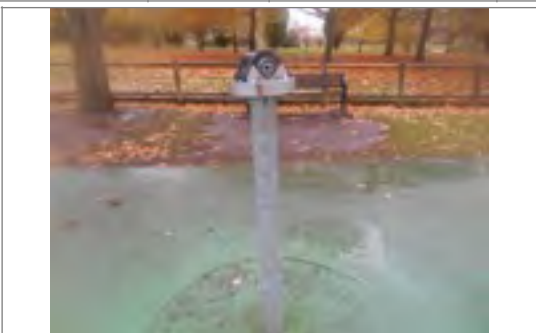
Missing component. Recommendation: Replace missing component.	4
---	--	---

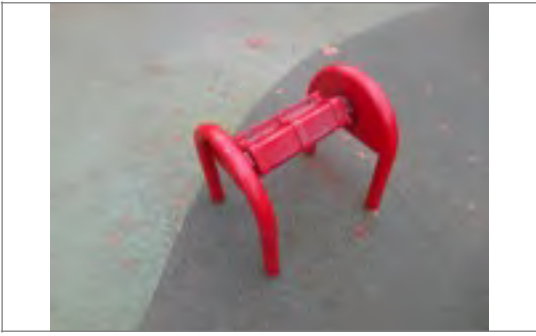
Missing component. Recommendation: Replace missing component.	4
---	--	---

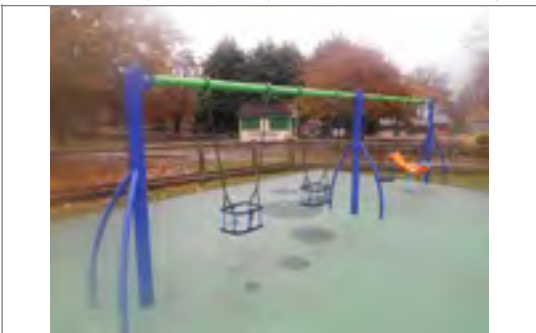
Split pin not fully engaged through hole. Recommendation: Drive pin fully through hole.	7
---	--	---

Slightly loose fixings. Recommendation: Monitor to retighten as necessary.	7
---	---	---

Chain wear evident. Recommendation: Monitor and replace at 40% dia. wear.	8
---	--	---

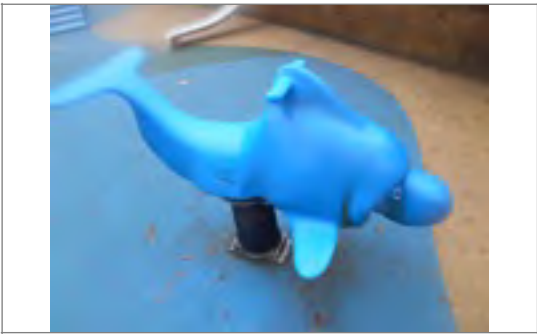
Slightly loose top fixings evident.
Recommendation:
Retighten as required.

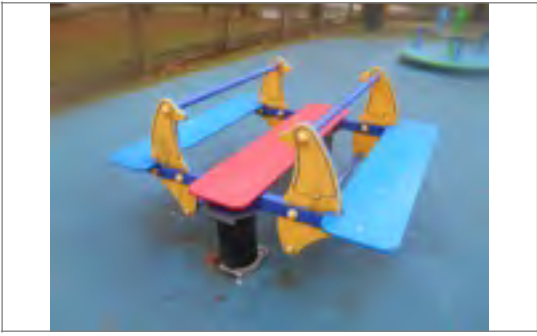
Missing fixing on seat. Recommendation: Replace fixing.	5
---	--	----------

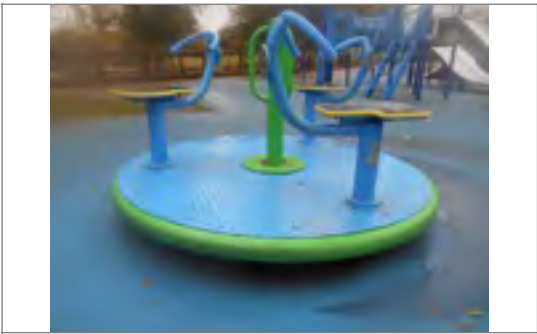
Edge shrinkage evident in places. Recommendation: Monitor to repair as required.	6
---	---	----------

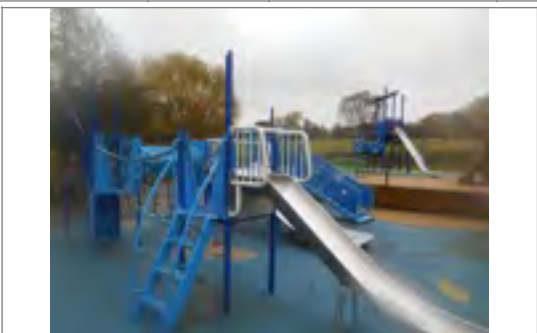
Missing fixing on half log bridge. Recommendation: Replace fixing.	7
---	---	----------

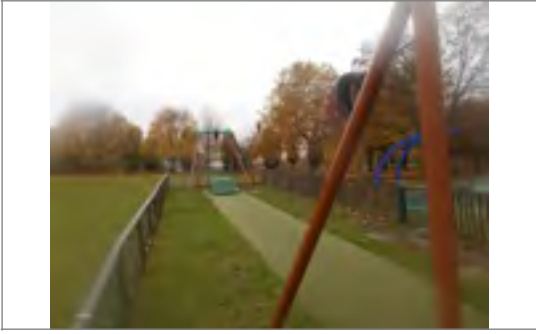
Missing button seat and chain. Recommendation: Replace item.	4
---	---	----------

Decay/rot evident to half logs on ramp. Recommendation: Monitor to replace as required.	8
---	--	----------

Zip Line mechanism and cable. Recommendation: Follow manufacturers recommendations of schedule of maintenance and inspections of this unit.	8
---	--	----------
