ESTATES AND FACILITIES

10249 PLAYGROUND INSPECTIONS (Report B)

Annual Inspection Report

New Barn Park Play Area

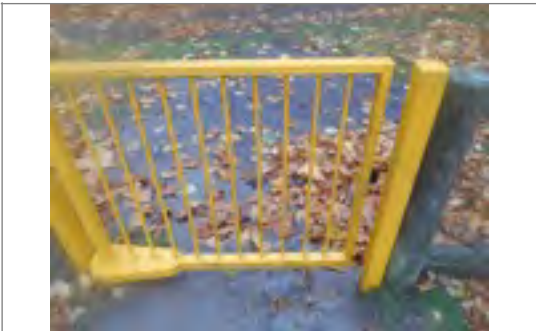
<p>Gate not fully closing.</p> <p>Recommendation: Adjust closing mechanism.</p>	7
---	--	----------

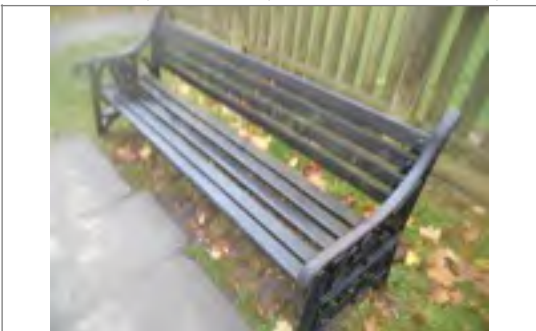
Surface trip hazard.
Recommendation:
 Make good surfacing.

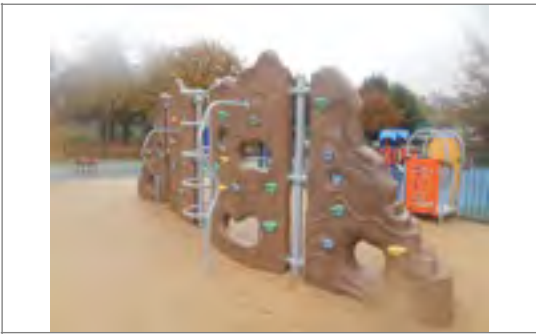
No faults found.
Recommendation:
 Monitor use.

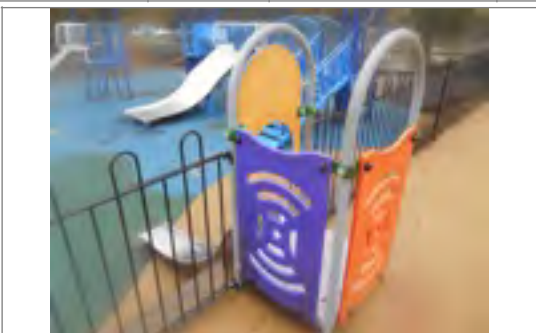
No faults found.
Recommendation:
 Monitor use.

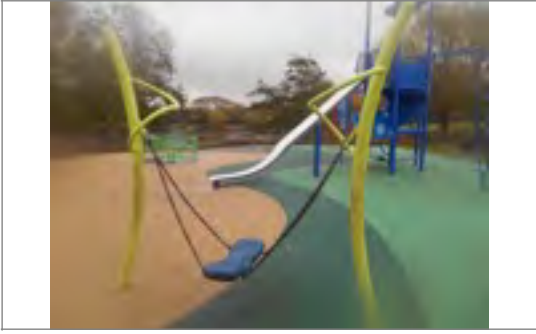
No faults found. Recommendation: Monitor use.	5
---	--	---

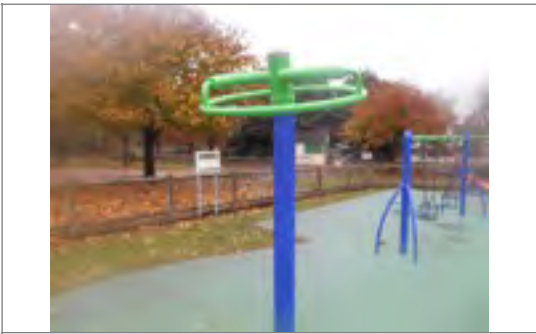
No faults found. Recommendation: Monitor use.	4
---	--	---

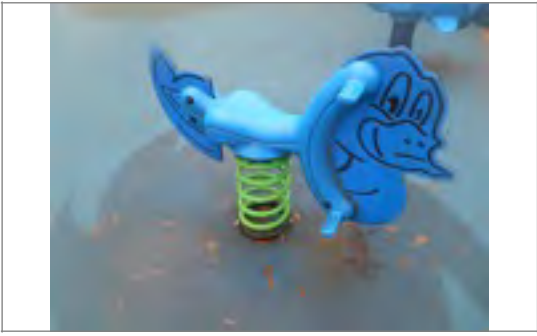
No faults found.
Recommendation:
Monitor use.

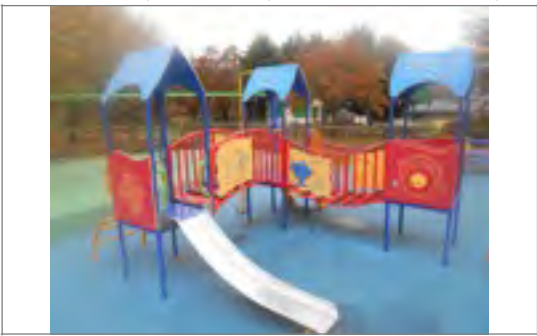
No faults found.
Recommendation:
Monitor use.

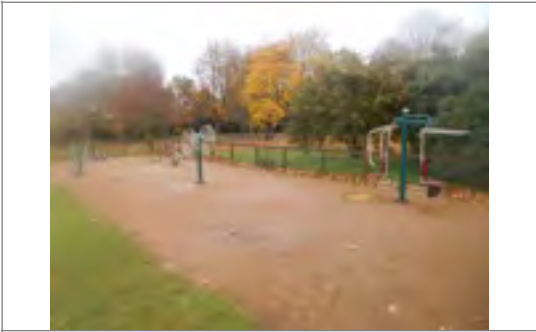
All gym items. Recommendation: Follow manufacturers recommendations of schedule of maintenance and inspections of all these items.	8
---	---	----------

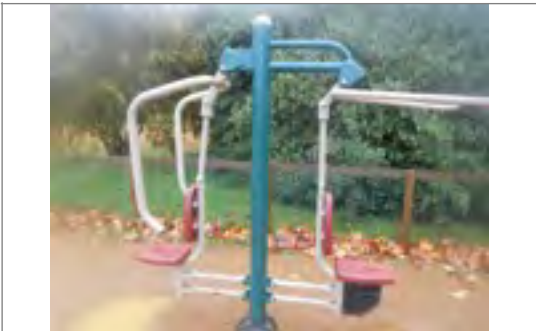
Loose fixings. Recommendation: Follow manufacturers recommendations of schedule of maintenance and inspections of this unit.	8
---	---	----------

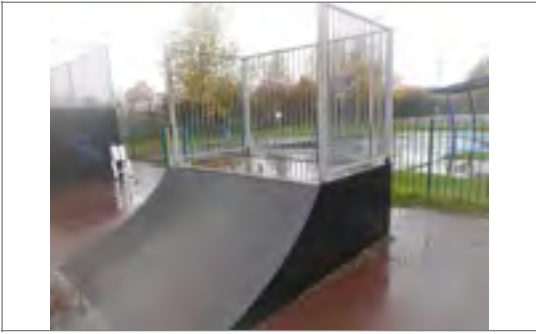
Transition problems evident with loose or missing fixings. Recommendation: Consider repairs to improve this condition.	10
	Recommendation:	
	Recommendation:	
	Recommendation:

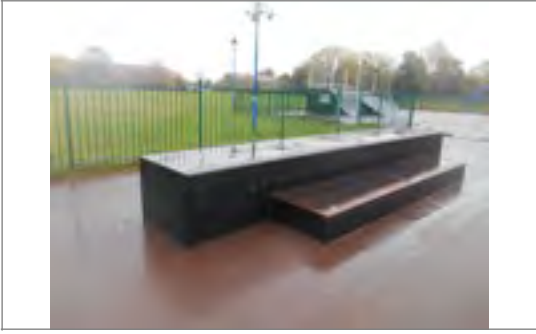
Item	Spine ramp				
Supplier	Local				
Surface	Steel				
Risk Rating Overall	Very Low	Low	Medium	High	Unacceptable
			10

Transition problems evident with loose or missing fixings. Recommendation: Consider repairs to improve this condition.	10
	Recommendation:	
	Recommendation:	
	Recommendation:

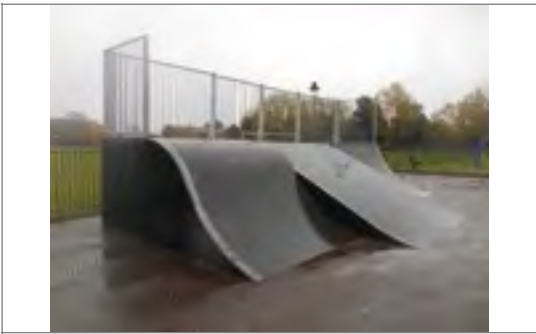
Item	Table top combination.				
Supplier	Local				
Surface	Steel				
Risk Rating Overall	Very Low	Low	Medium	High	Unacceptable
			10

Broken welds evident in places. Recommendation: Repair this condition.	8
---	---	---

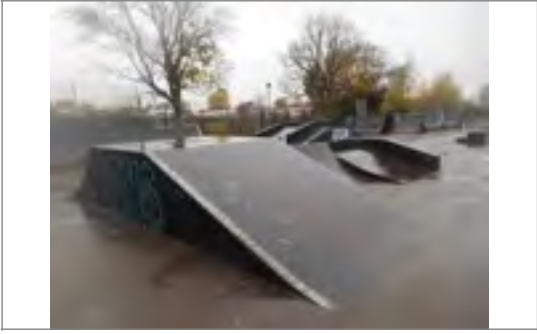
Various missing rails. Recommendation: Replace as necessary.	10
---	---	----

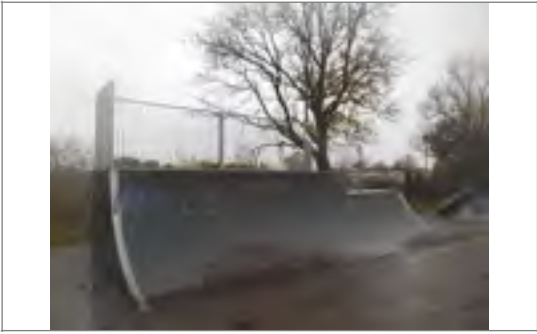
Item	Flat/Curved ramp combination				
Supplier	Local				
Surface	Steel				
Risk Rating Overall	Very Low	Low	Medium	High	Unacceptable
			10

Missing fixings to ground supports. Recommendation: Repair as necessary.	8

As above finding. Recommendation: As above comment.	8

Tarmac sinking in places. Recommendation: Repair as required.	8

Transition problems evident with loose or missing fixings. Recommendation: Consider repairs to improve this condition.	10

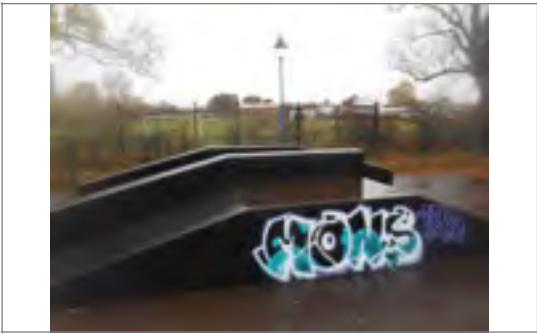
Item	Quarter Pipe combination ramps				
Supplier	Local				
Surface	Steel				
Risk Rating Overall	Very Low	Low	Medium	High	Unacceptable
			12

As above finding. Recommendation: As above comment.	10

As above. Recommendation: As above.	10
	Recommendation:	
	Recommendation:

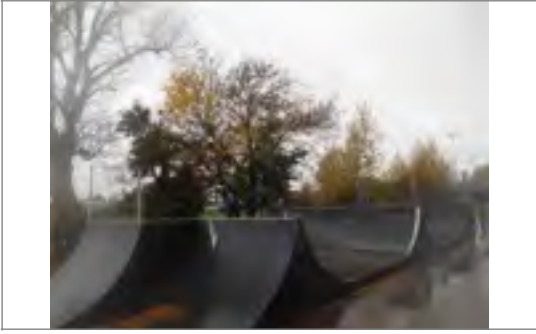
Item	Spine combination ramp				
Supplier	Local				
Surface	Steel				
Risk Rating Overall	Very Low	Low	Medium	High	Unacceptable
			10

Transition problems evident with loose or missing fixings. Recommendation: Consider repairs to improve this condition.	10
 	As above finding. Recommendation: As above comment.	10
	Recommendation:	
	Recommendation:

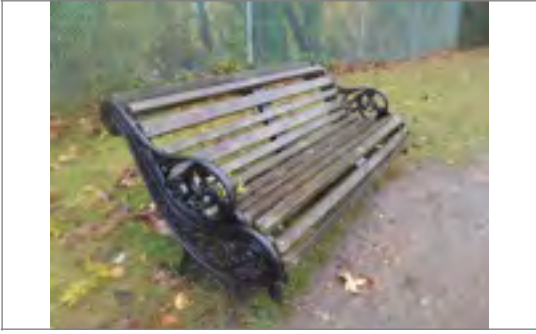
Exposed nails evident. Recommendation: Repair as necessary.	7
	Recommendation:	
	Recommendation:	
	Recommendation:

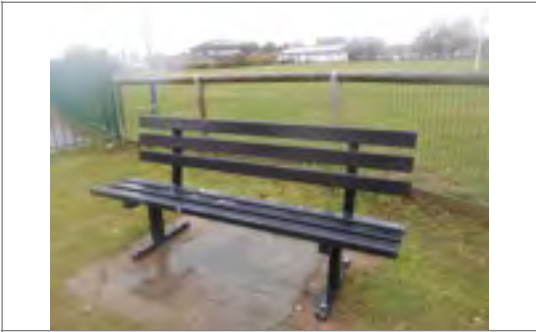
Item	Bench				
Supplier	Unknown				
Surface	N/a				
Risk Rating Overall	Very Low	Low	Medium	High	Unacceptable
		5

Slight decay evident.
Recommendation:
 Monitor to replace as required.

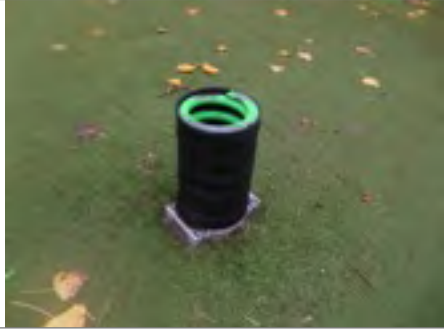
Item	Litter Bin(s)				
Supplier	Unknown				
Surface	N/a				
Risk Rating Overall	Very Low	Low	Medium	High	Unacceptable
		4

Rust/corrosion evident.
Recommendation:
 Consider repairs or a new litter bin.
